# Manhole Inspection Summary

Manhole # S31CC\_017MH

**Location** Address: **201 PRESTON ST**

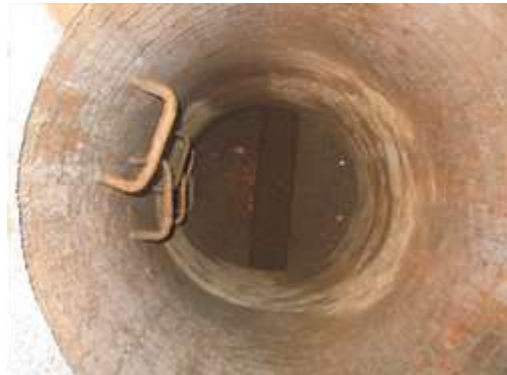
Top View

Corroded steps. Evidence of surcharge - Bench debris. Channel debris.

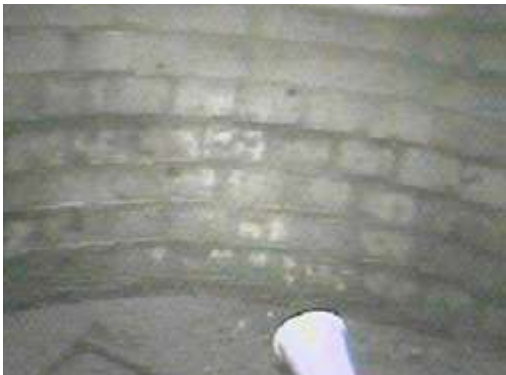
Defect

Barrel infiltration.

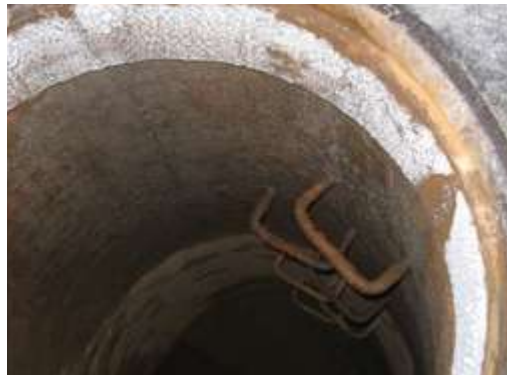
Defect

Frame leaks. Adjustment and Barrel infiltration - other side.

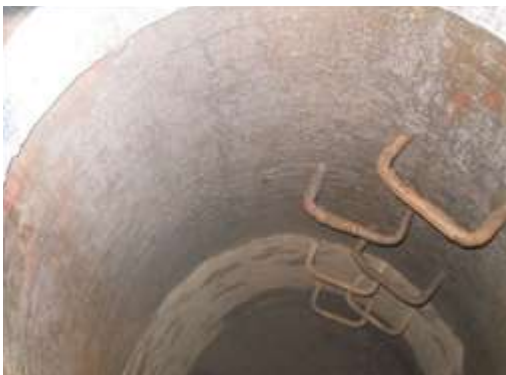
Defect

Frame leaks. Adjustment and Barrel infiltration.

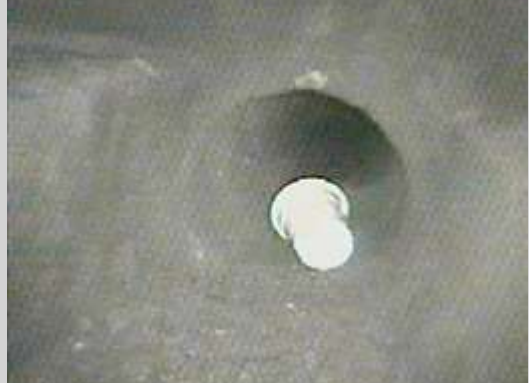
### 10 in. Circular Gravity Sewer Pipe Out @ 12 O'Clock

Deposits: ☐ None ☒ **Mud** ☐ Sludge ☒ **Debris** ☐ Grease

Silt Depth: **0.5** (in.) Deposits Extent: **Light**

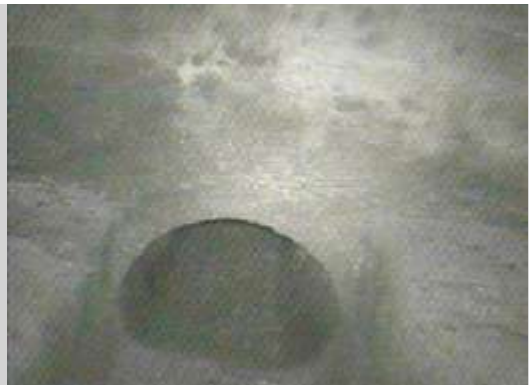
### 10 in. Circular Gravity Sewer Pipe In @ 6 O'Clock

Deposits: ☐ None ☒ **Mud** ☐ Sludge ☒ **Debris** ☐ Grease

Silt Depth: **0.5** (in.) Deposits Extent: **Light**
